UNITED STATES ENVIRONMENTAL PROTECTION AGENCY

Subject: Seven Out Tank Site/Francis Street Site Assessment  
Waycross, Ware County, Georgia

U.S. ENVIRONMENTAL PROTECTION AGENCY  
POLLUTION/SITUATION REPORT  
Francis Street Assessment  
Removal Site Evaluation POLREP

**Subject:** POLREP  
Removal Site Evaluation  
Francis Street Site Assessment (Concerning the "Seven Out Tank Site")  
901 Francis Street, Waycross, Ware County, Georgia

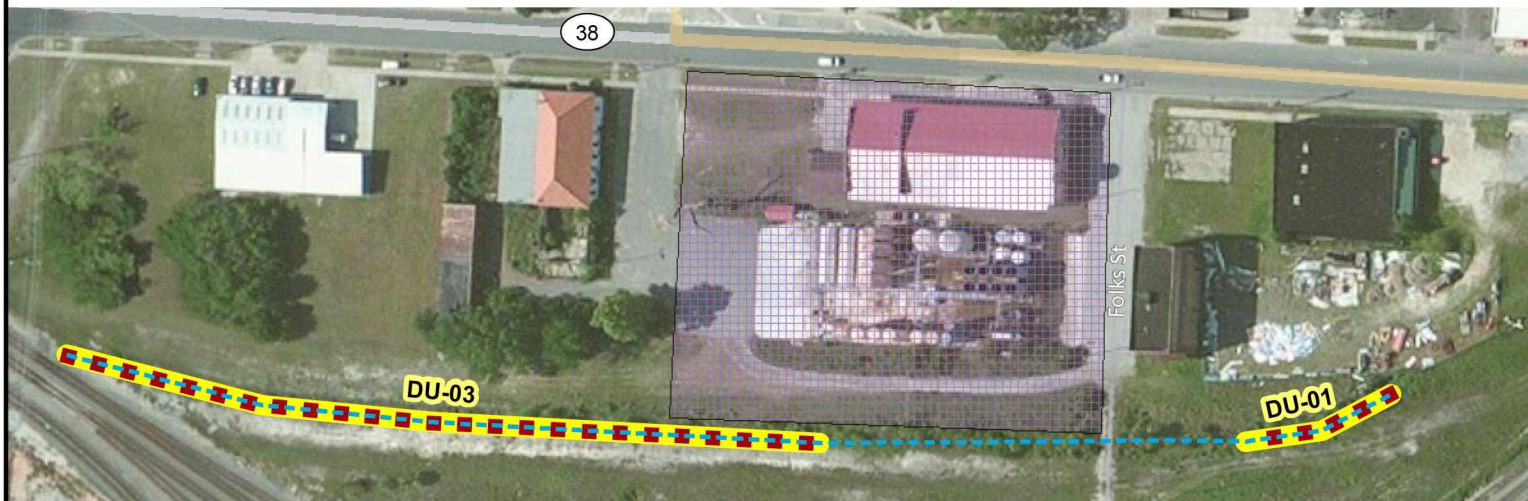
- Measured Segment of Drainage Ditch
- Decision Unit
- Former Seven Out Facility

EPA's recommendation for additional work in the September 19, 2013 Special POLREP (Attachment 1) included the completion of a detailed and up-to-date drainage path evaluation to determine whether previous statements of runoff behavior from the Site were either inaccurate or have changed. The Drainage Path Evaluation is provided in Appendix 3. The evaluation concluded that observed drainage patterns at the Seven Out Tank Site and surrounding area (within the boundaries of the Site and DU01 through DU05) have not changed since 2004.

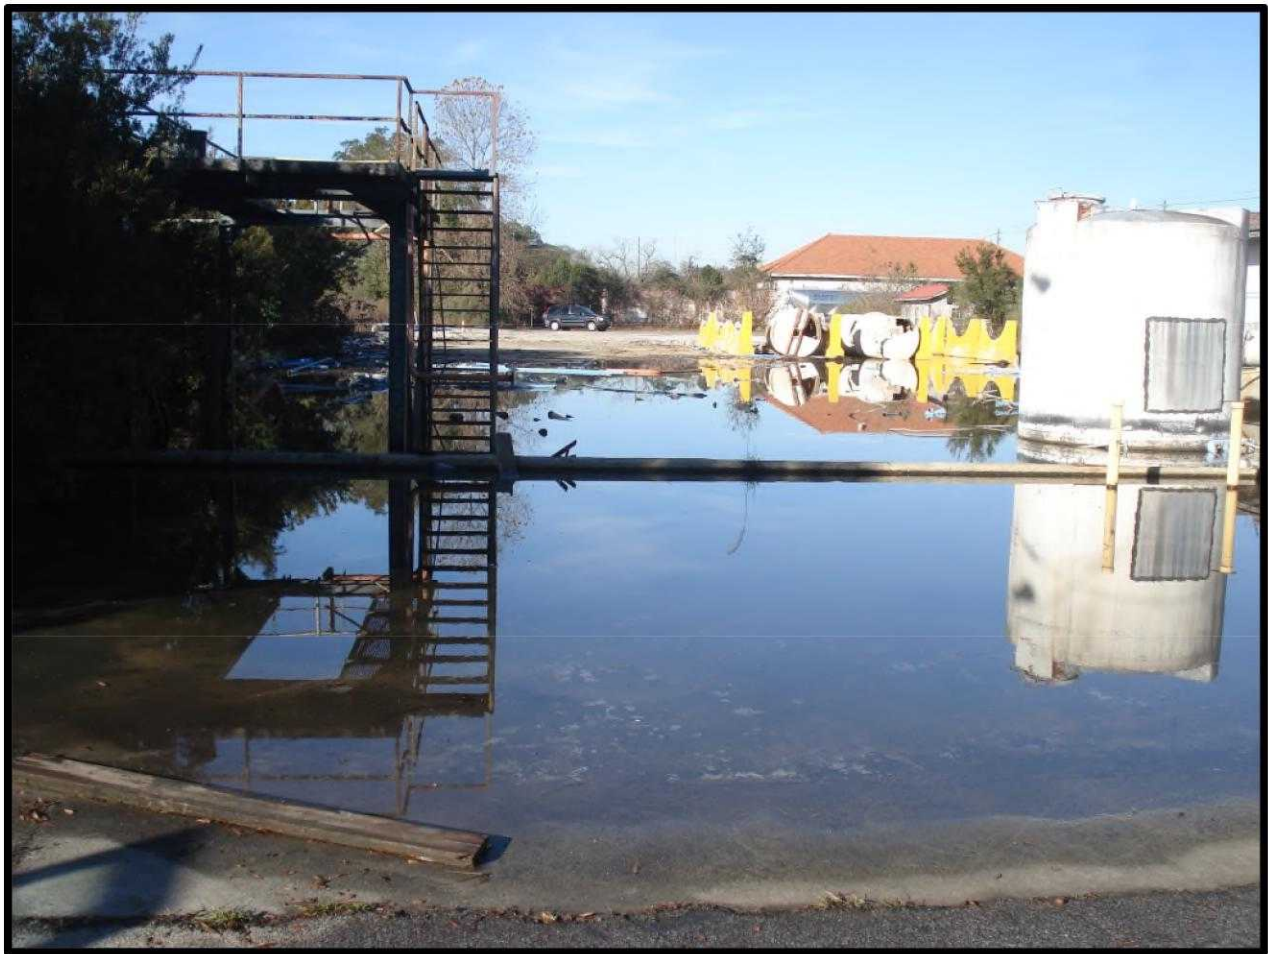
**OFFICIAL PHOTOGRAPH NO. 1**  
**U.S. ENVIRONMENTAL PROTECTION AGENCY**

**Subject:** The former Seven Out wastewater treatment facility (located at 901 Francis Street, Waycross, Ware County, Georgia) as well as surrounding stormwater drainage pathways, was the focus of the Francis Street Assessment. The former facility has been decommissioned, and most of the structures and equipment associated with former operations have been demolished and removed. Soil samples FSA-SF-SCW and FSA-SF-SCW-DUP were collected south (out of frame) of the former filter press platform visible on the left of the frame.

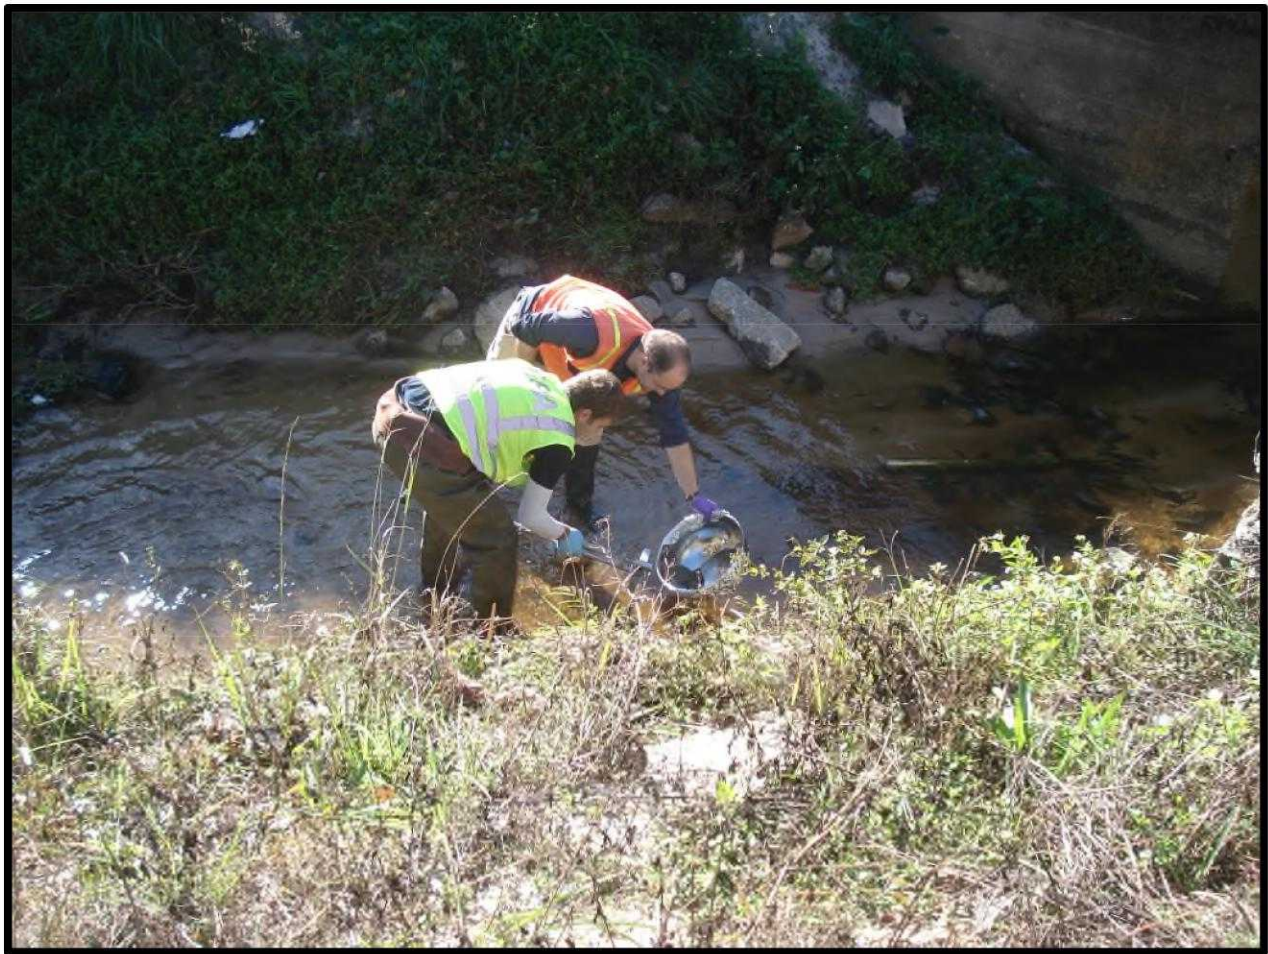
**OFFICIAL PHOTOGRAPH NO. 3**  
**U.S. ENVIRONMENTAL PROTECTION AGENCY**

**Subject:** Tetra Tech field team members, U.S. Environmental Protection Agency (EPA) personnel, Ware County Health Department personnel, and Georgia Department of Public Health personnel participated in the sampling event. Sediment samples from five decision units (DU) were collected using incremental sampling methodology (ISM). ISM sampling was conducted using a specialized ISM sampler and stainless steel bowls and spoons.

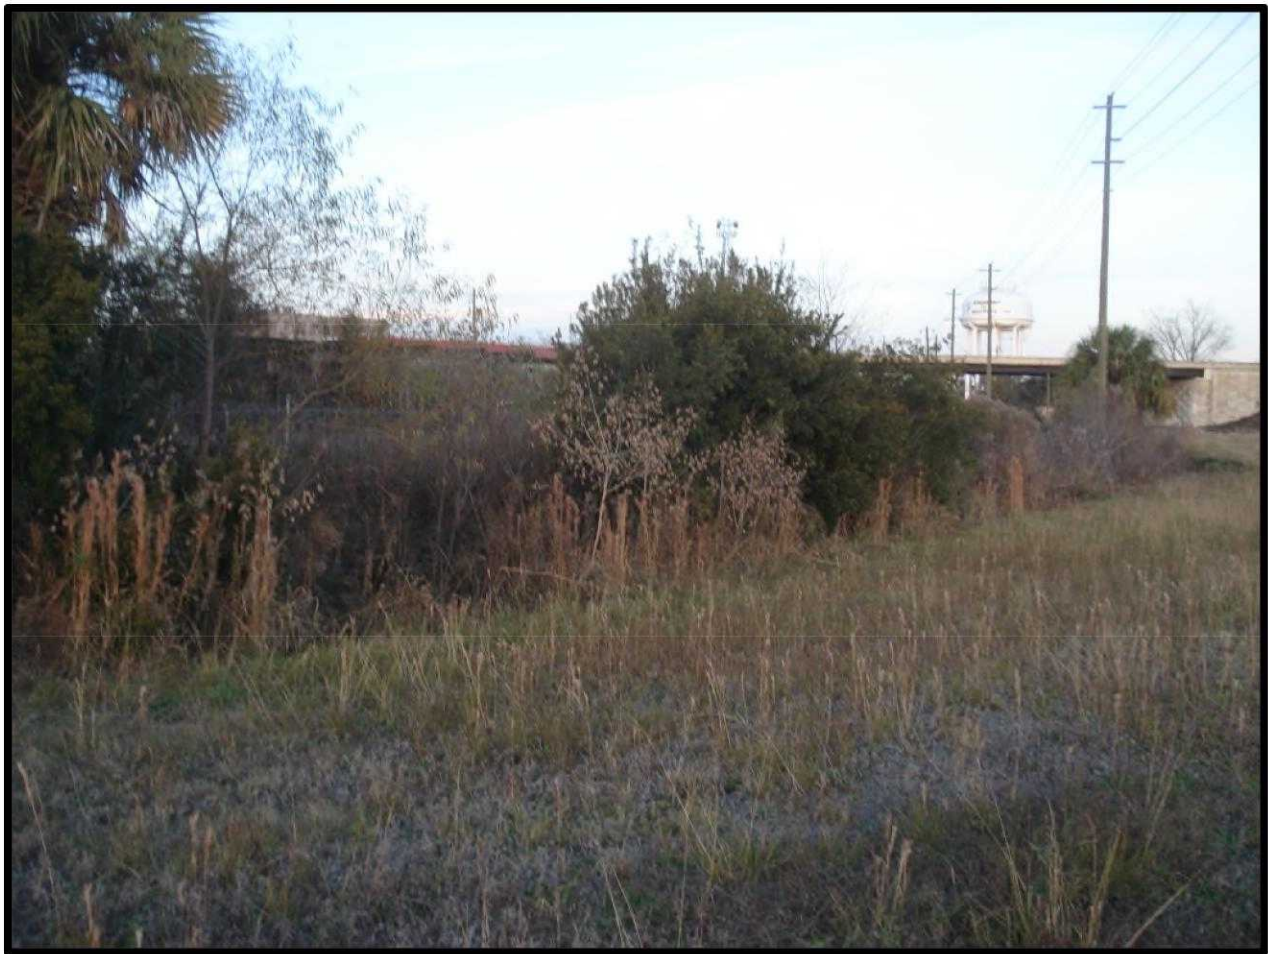
**OFFICIAL PHOTOGRAPH NO. 4**  
**U.S. ENVIRONMENTAL PROTECTION AGENCY**

<b>TDD Number:</b>	TTEMI-05-003-0168	<b>Location:</b>	Francis Street Assessment
<b>Orientation:</b>	East	<b>Date:</b>	December 19, 2013
<b>Photographer:</b>	John Snyder, Tetra Tech	<b>Witness:</b>	Amber Skiles, Tetra Tech
<b>Subject:</b>	The portion of the drainage ditch east of the former Seven Out Site was designated DU-01 and served as the background sediment sample location.

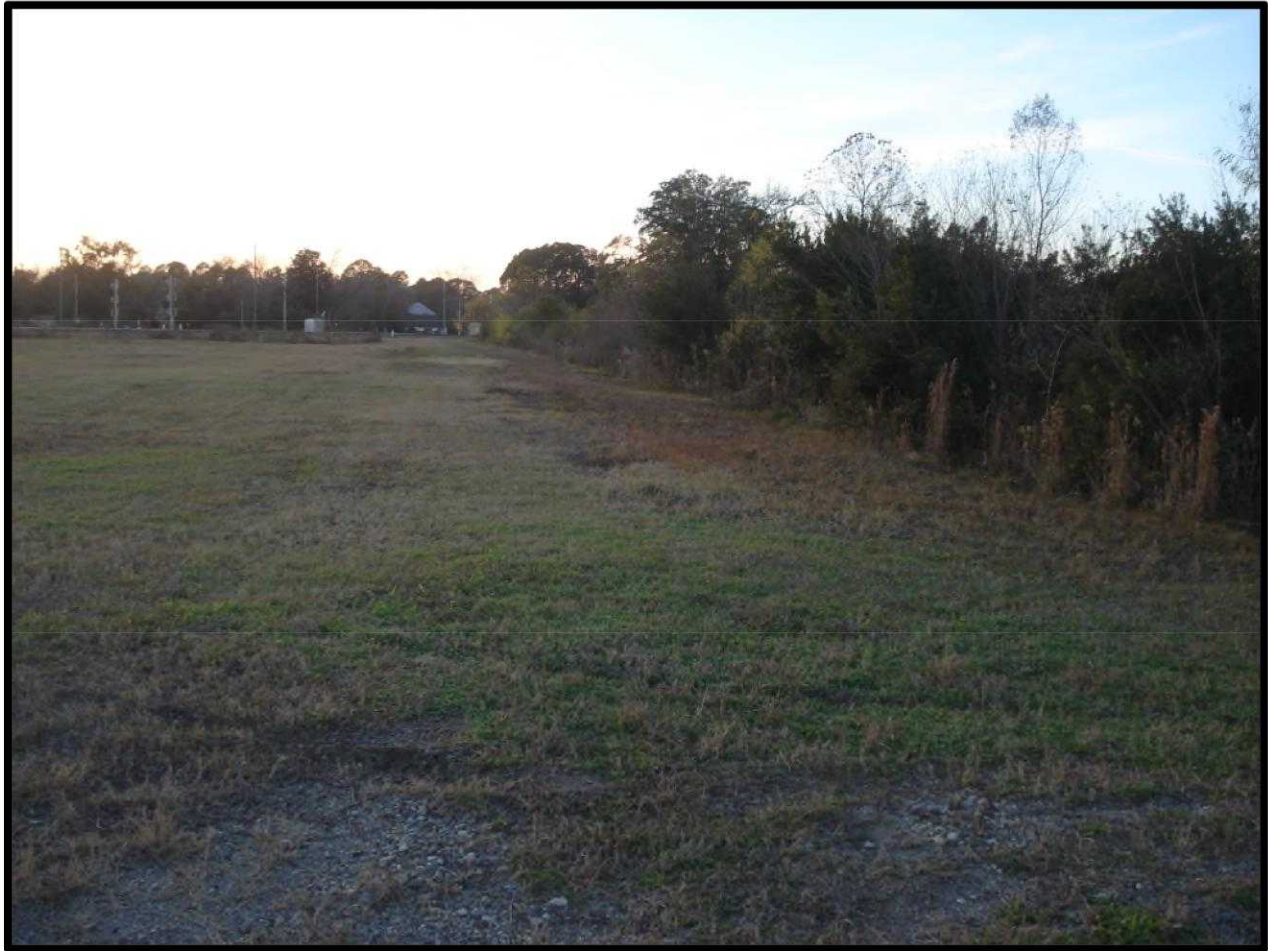
**OFFICIAL PHOTOGRAPH NO. 5**  
**U.S. ENVIRONMENTAL PROTECTION AGENCY**

<b>TDD Number:</b>	TTEMI-05-003-0168	<b>Location:</b>	Francis Street Assessment
<b>Orientation:</b>	West	<b>Date:</b>	December 19, 2013
<b>Photographer:</b>	John Snyder, Tetra Tech	<b>Witness:</b>	Amber Skiles, Tetra Tech
<b>Subject:</b>	The portion of the drainage ditch running between the former Seven Out Site and the railroad tracks west of the Site was designated DU-03.

DU-03 is within the drainage ditch section that receives stormwater from the facility, beginning downstream of the intersection of DU-01 and DU-02 but ending before the intersection with a drainage ditch from the CSX Rice Yard property near S Nichols Street. The size, condition, and features of DU-03 are similar to DU-01 and DU-02. This DU was selected for two reasons: 1) measure PAH concentrations in the ditch prior to entering the canal; and, 2) to evaluate whether downstream concentrations of PAHs were measurably higher than upstream concentrations immediately adjacent to the Site.

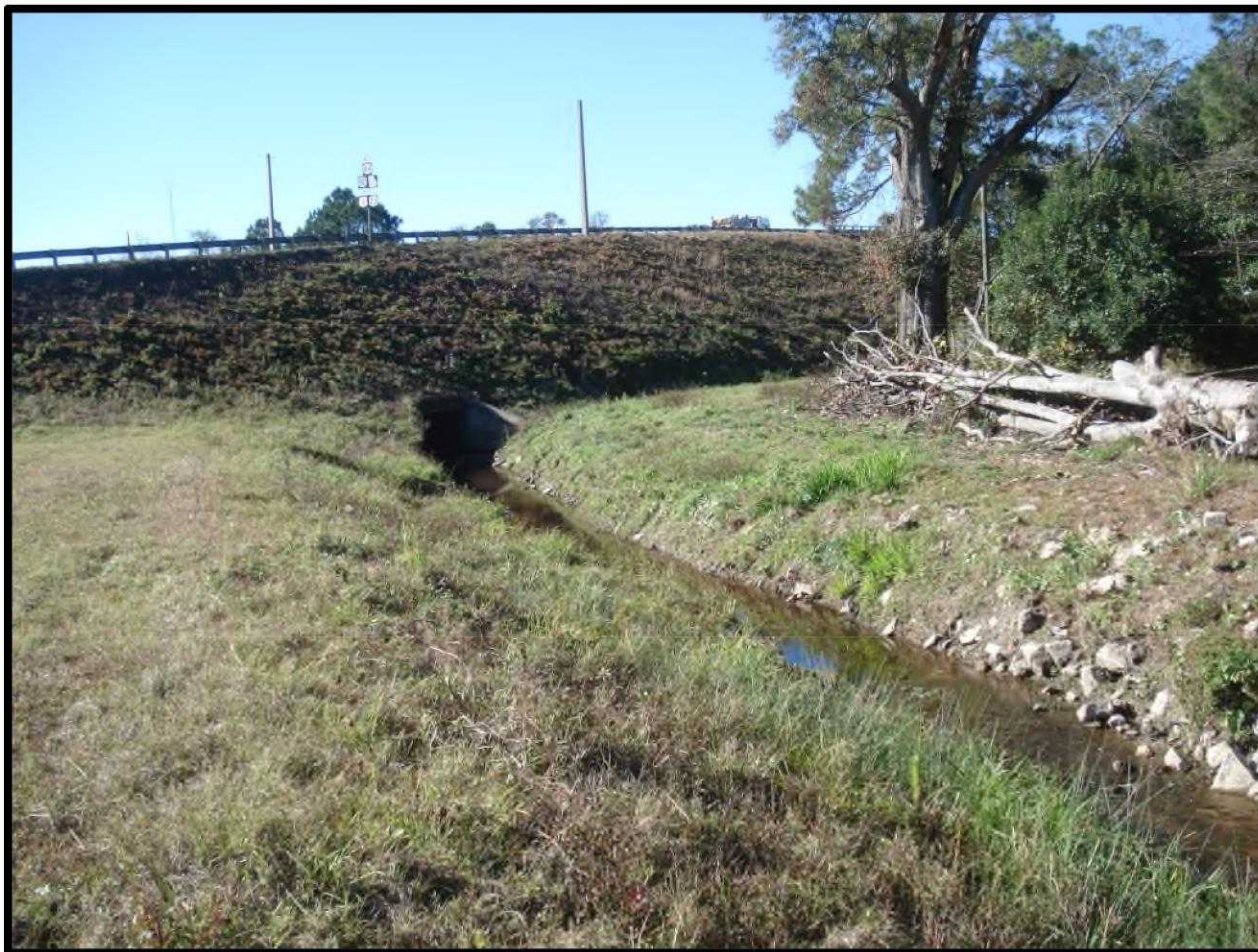
**OFFICIAL PHOTOGRAPH NO. 6**  
**U.S. ENVIRONMENTAL PROTECTION AGENCY**

<b>TDD Number:</b>	TTEMI-05-003-0168	<b>Location:</b>	Francis Street Assessment
<b>Orientation:</b>	South	<b>Date:</b>	December 19, 2013
<b>Photographer:</b>	John Snyder, Tetra Tech	<b>Witness:</b>	Amber Skiles, Tetra Tech
<b>Subject:</b>	The portion of the drainage canal running between the Highway 82 overpass (background of frame) and Folk Street was designated DU-05.
